**FRENCH RIVER BASIN
OXFORD, MASSACHUSETTS**

**ROBINSON POND DAM
MA 00670**

PHASE I INSPECTION REPORT NATIONAL DAM INSPECTION PROGRAM

JULY 1978

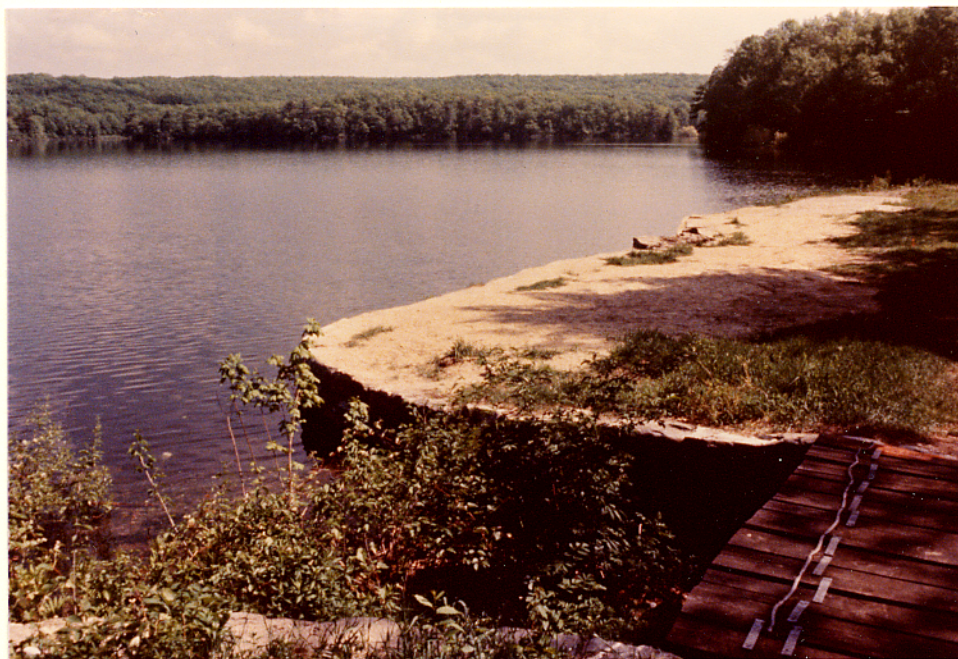
**VIEW LOOKING SOUTH OF UPSTREAM DAM AREA
SHOWING SPILLWAY TRAINING WALLS**

Recent unauthorized filling of the dam crest, apparently to gain access over the dam, was noted in the area immediately south of the spillway. The elevation of the fill is not higher than the adjacent dam crest.

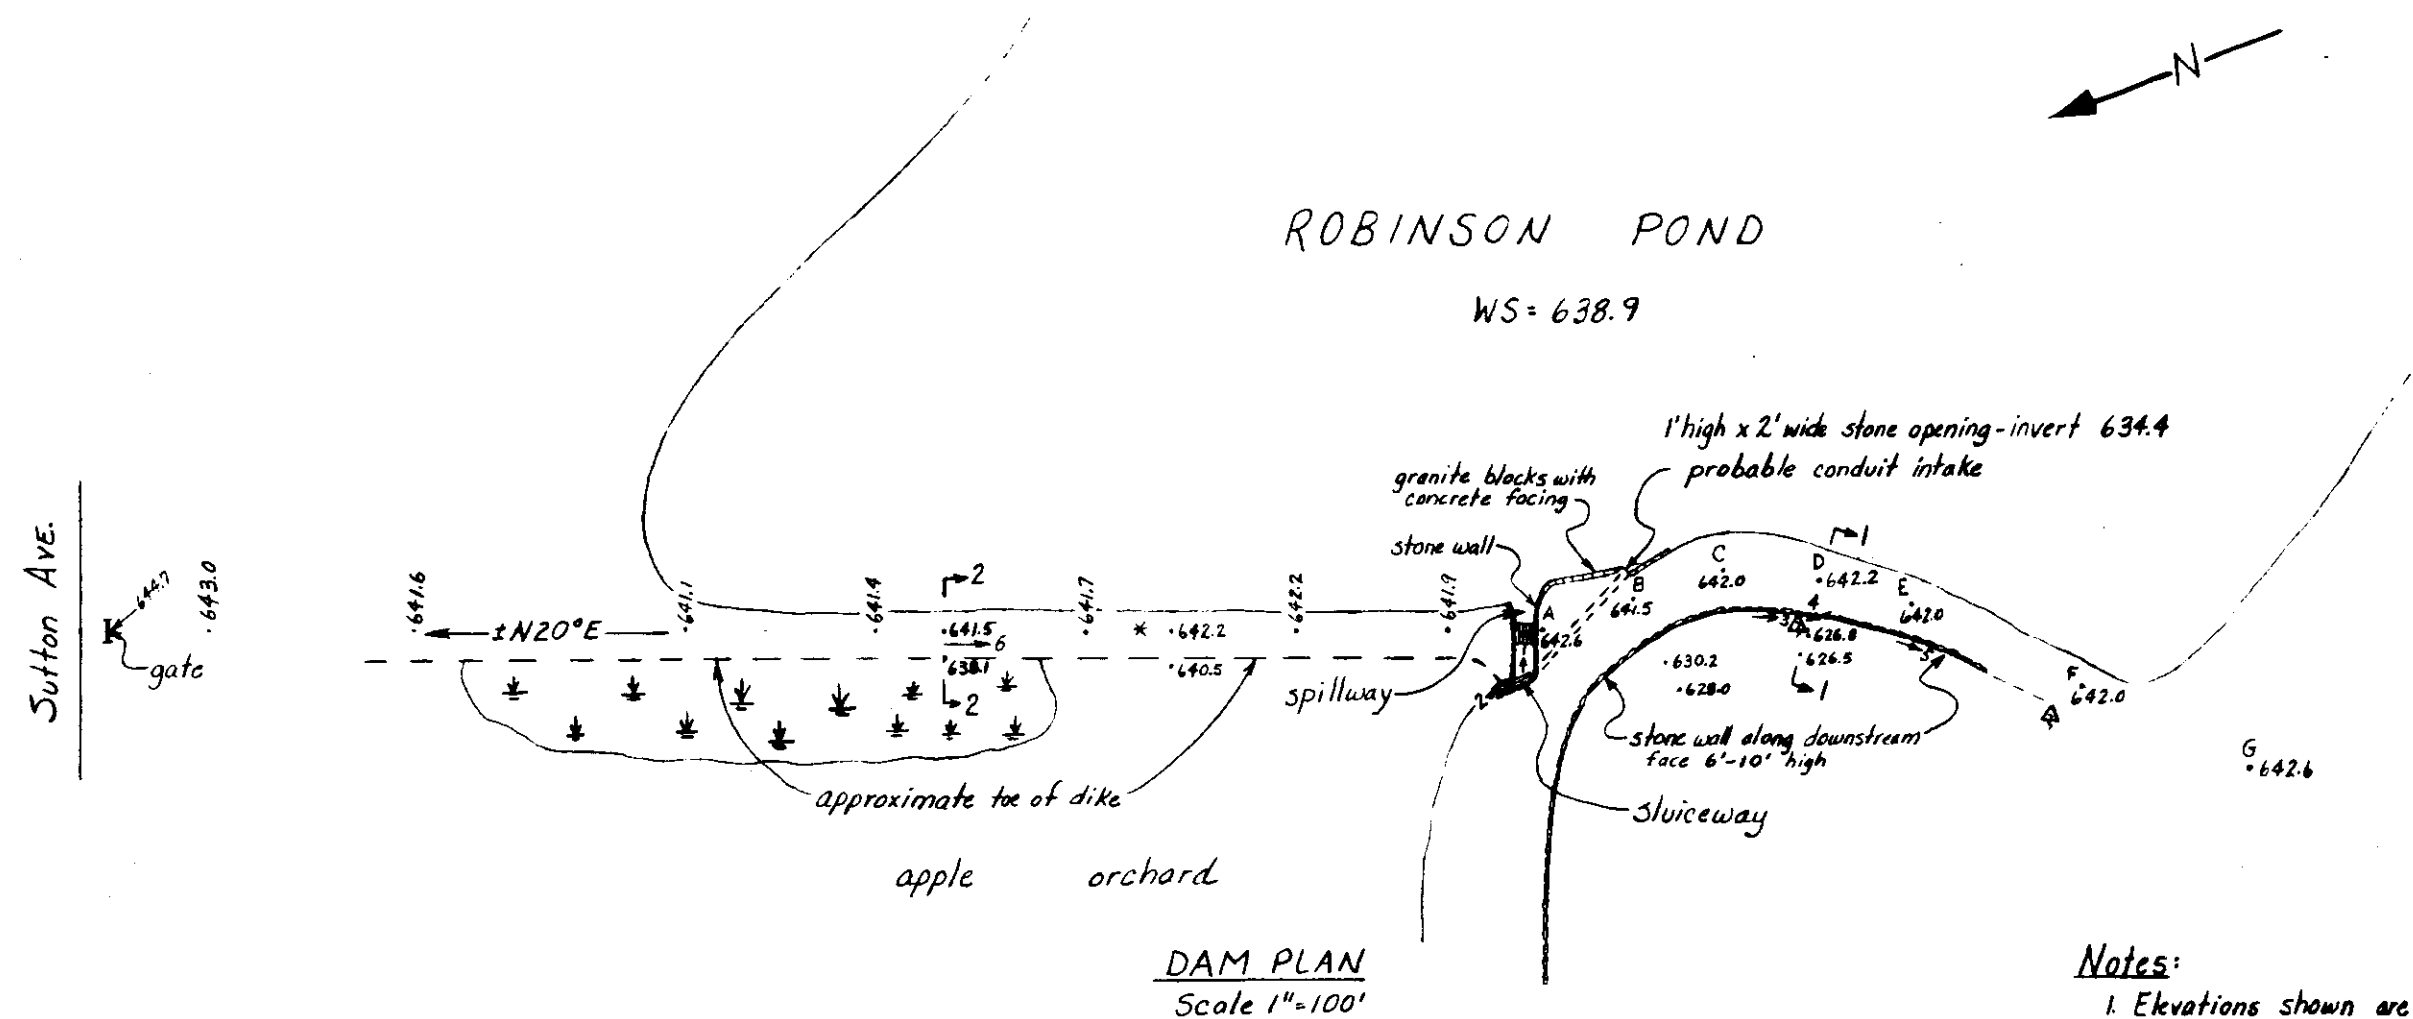
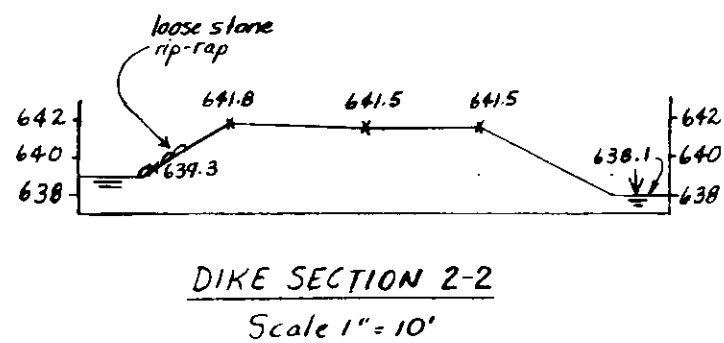
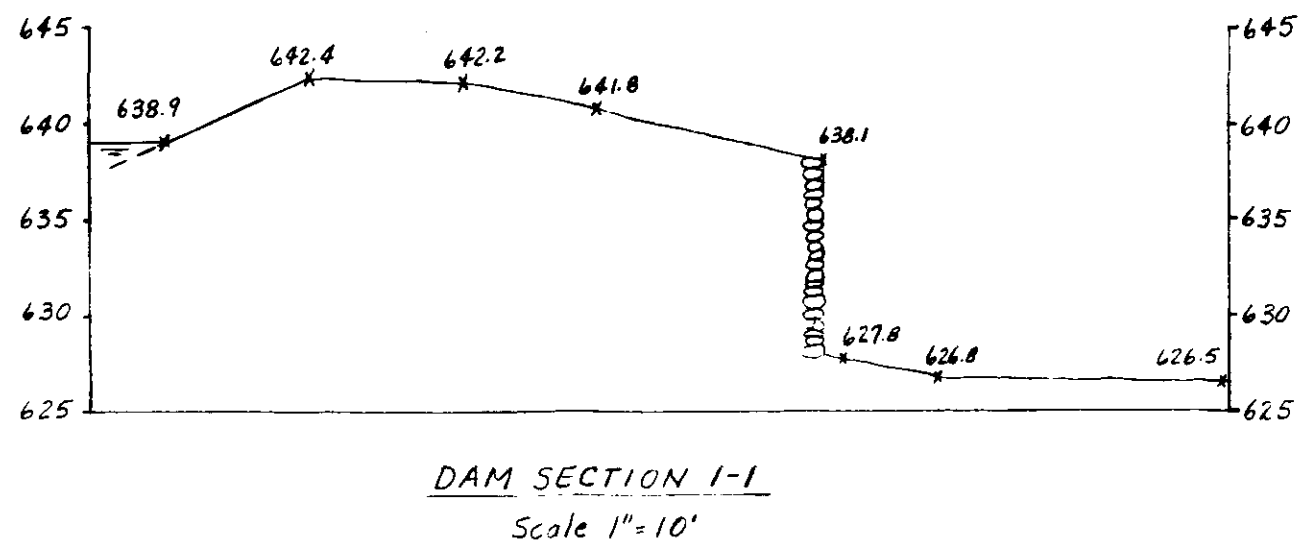
<u>Page</u>
B-1	Dam Plan and Sections - Figure B-1	B-1
B-2	Previous Inspections (Partial Listing)	B-2
B-3	Inspection Report by Mass. Department of Public Works (July 24, 1974)	B-3
B-4	Inspection Report by U. S. Army Corps of Engineers (August 1, 1974)	B-8

Slight to moderate seepage was noted at the downstream toe of the dam at two locations. A flow of about 2 to 3 gpm (gallons per minute) was observed seeping beneath the downstream toe near Point D (refer to Figure B-1). Also a flow less than 1 gpm was noted at the downstream toe of the dam near Point F. The seepage at both locations was flowing clear at the time of inspection. In previous inspections, representatives of the Worcester County Engineer's office have noted seepage through the dam as early as 1934 although the location is not specified.

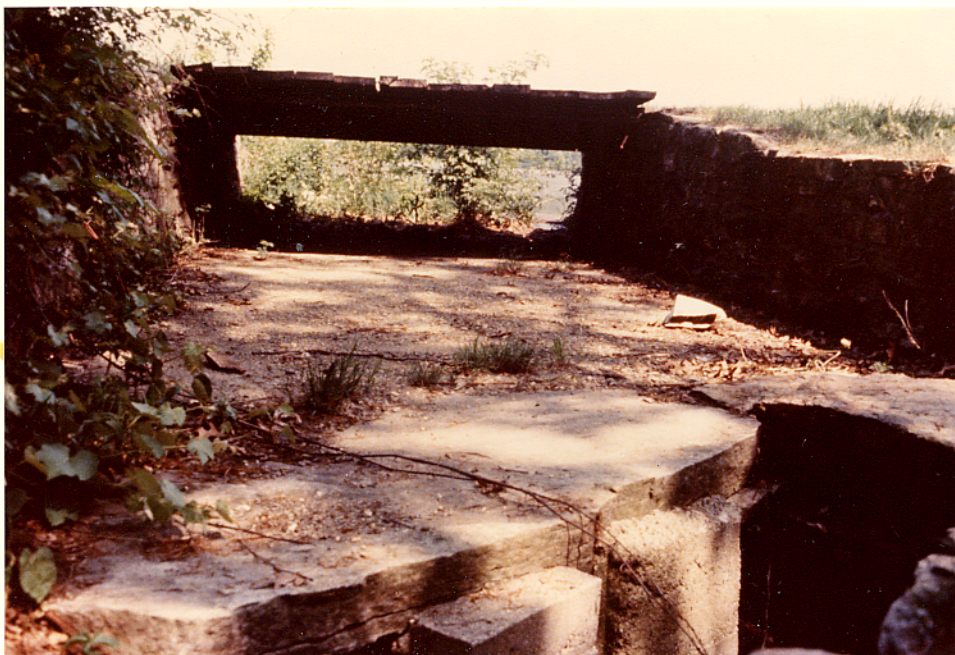
The spillway approach channel is partially restricted by debris, soil, and vegetation to a depth of about 3 to 6 inches. The spillway training walls are in fair to good condition. There is no evidence of wall movement or dislodgment of stones.

NO. 1 - VIEW OF SPILLWAY LOOKING EAST FROM SLUICEWAY

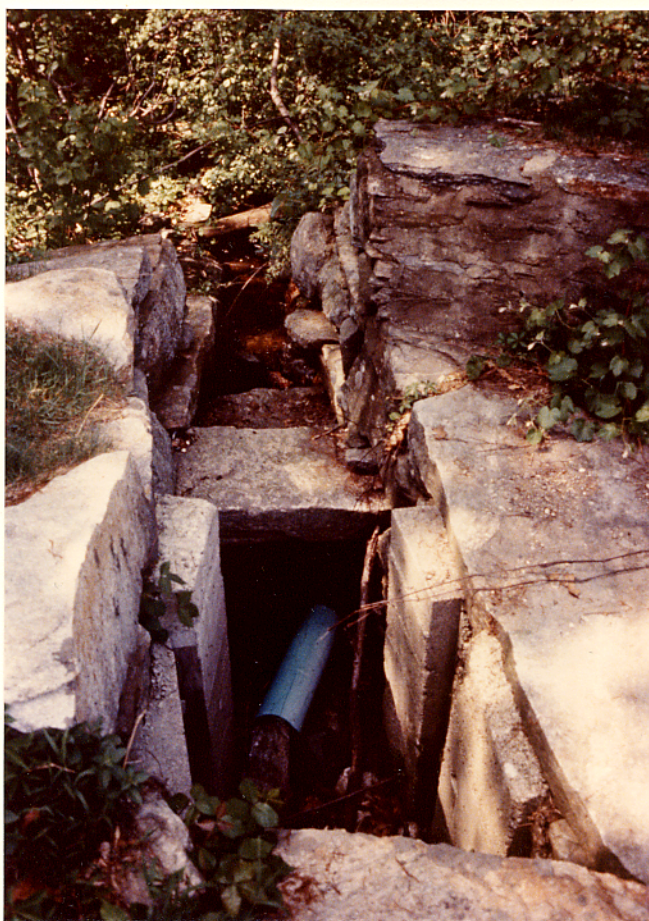
NO. 2 - VIEW OF SLUICEWAY LOOKING NORTHWEST

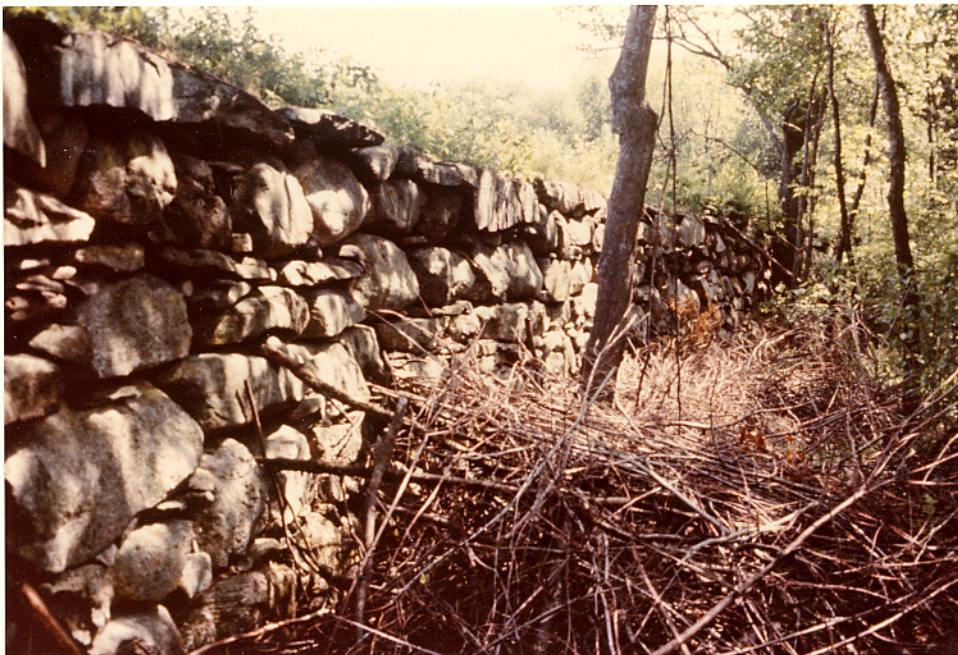
**NO. 3 - VIEW NORTH SHOWING WALL
AT DOWNSTREAM TOE AT STATION D**

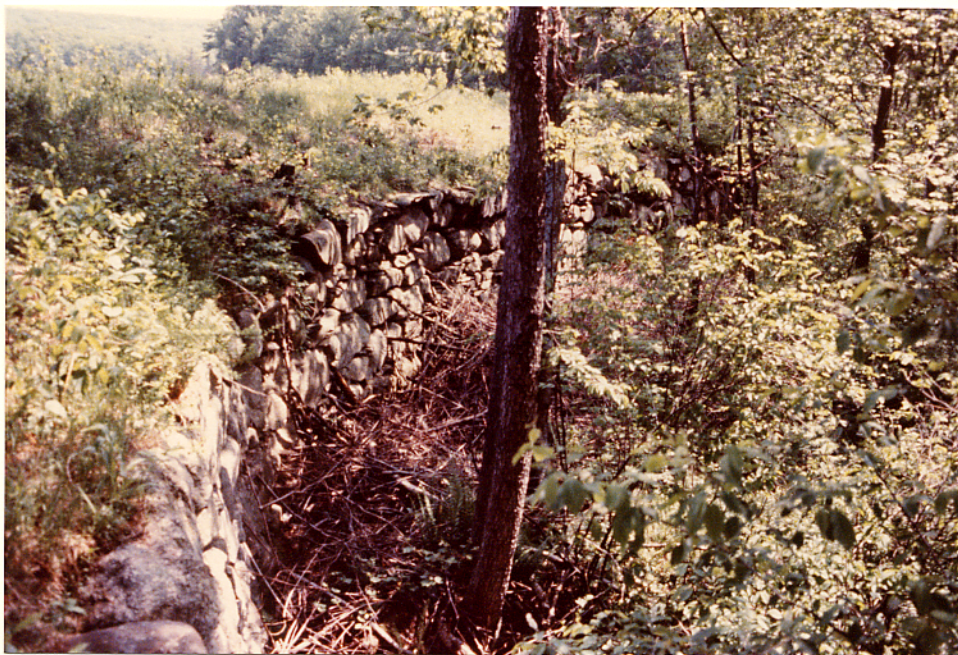
**NO. 4 - VIEW SOUTH SHOWING CLOSEUP OF WALL
AT DOWNSTREAM TOE AT STATION D**

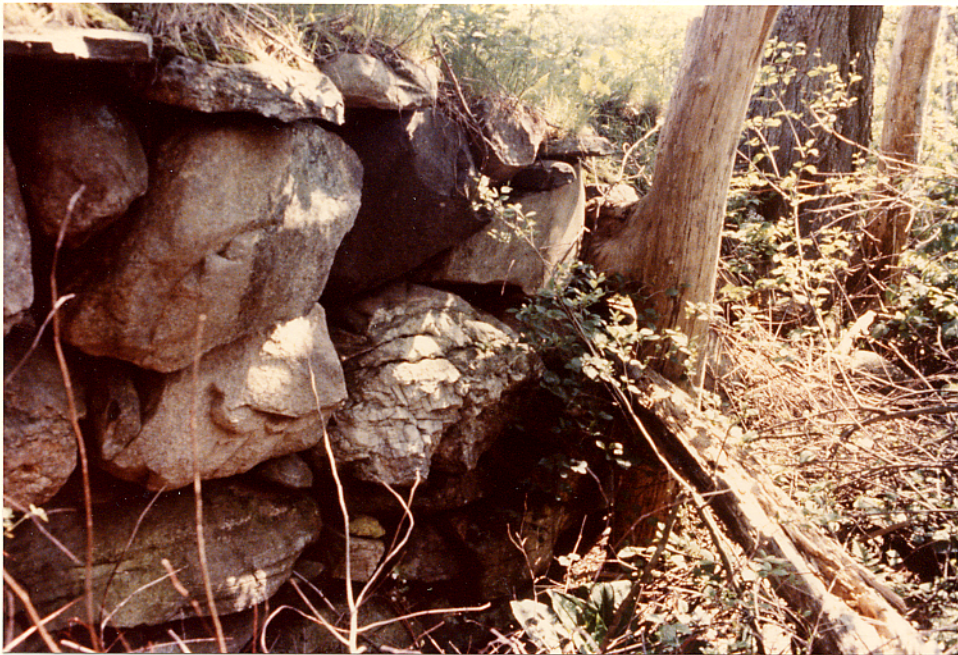
- b. Dam. The main dam is a dry-stone masonry and earthfill dam, and the dike section is an earth embankment. There is no information available on the zoning or core of either dam sections since they were constructed about 140 years ago. Several signs of distress are visible, the most severe being a bulge in the downstream stone wall at about 20 feet south of Point E as shown in Figure B-1 Dam Plan and Sections in Appendix B. A photograph of this bulge is shown in Appendix C. The bulge or dislodgment of stones was probably caused by the displacing action of large trees and frost.

NO. 5 - VIEW OF BULGE AT STATION E-20 LOOKING SOUTH

It is recommended that a more detailed investigation be initiated to evaluate the bulging of the stone wall on the downstream face of the dam and the seepage at the downstream toe of the dam.

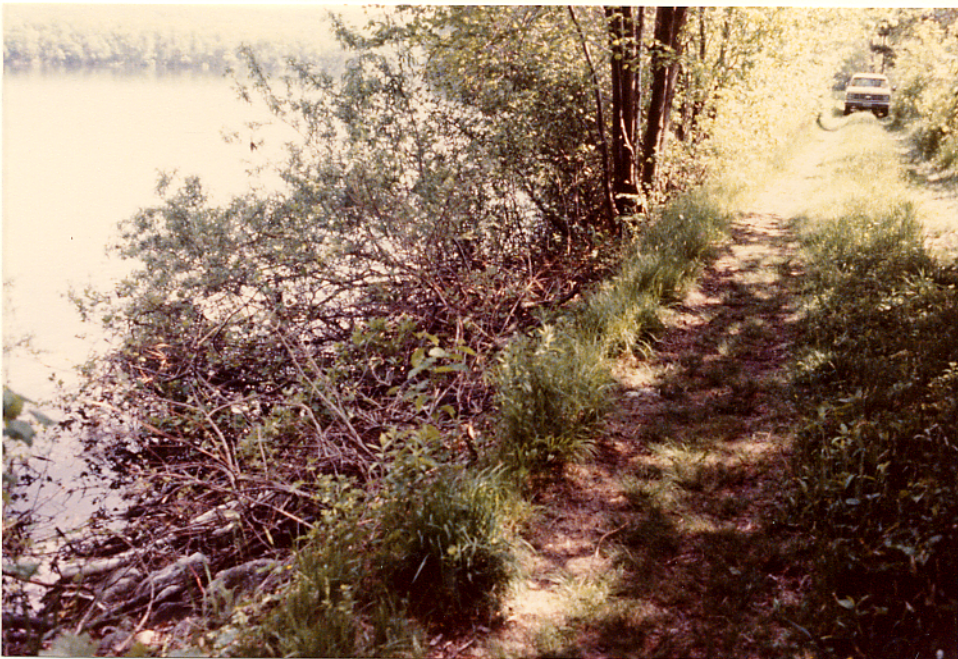
**NO. 6 - VIEW OF DIKE LOOKING SOUTH
ABOUT 300 FEET NORTH OF SPILLWAY**
